MMC Materials, Inc.
TNG110370 - Frayser Plant

Project No.:	Site Location:	Permittee:	Date:	Time On-Site
TNG110370	2941 Frayser Blvd., Memphis, Shelby County, TN	MMC Materials, Inc.	Sept. 26, 2016	15:45 PM

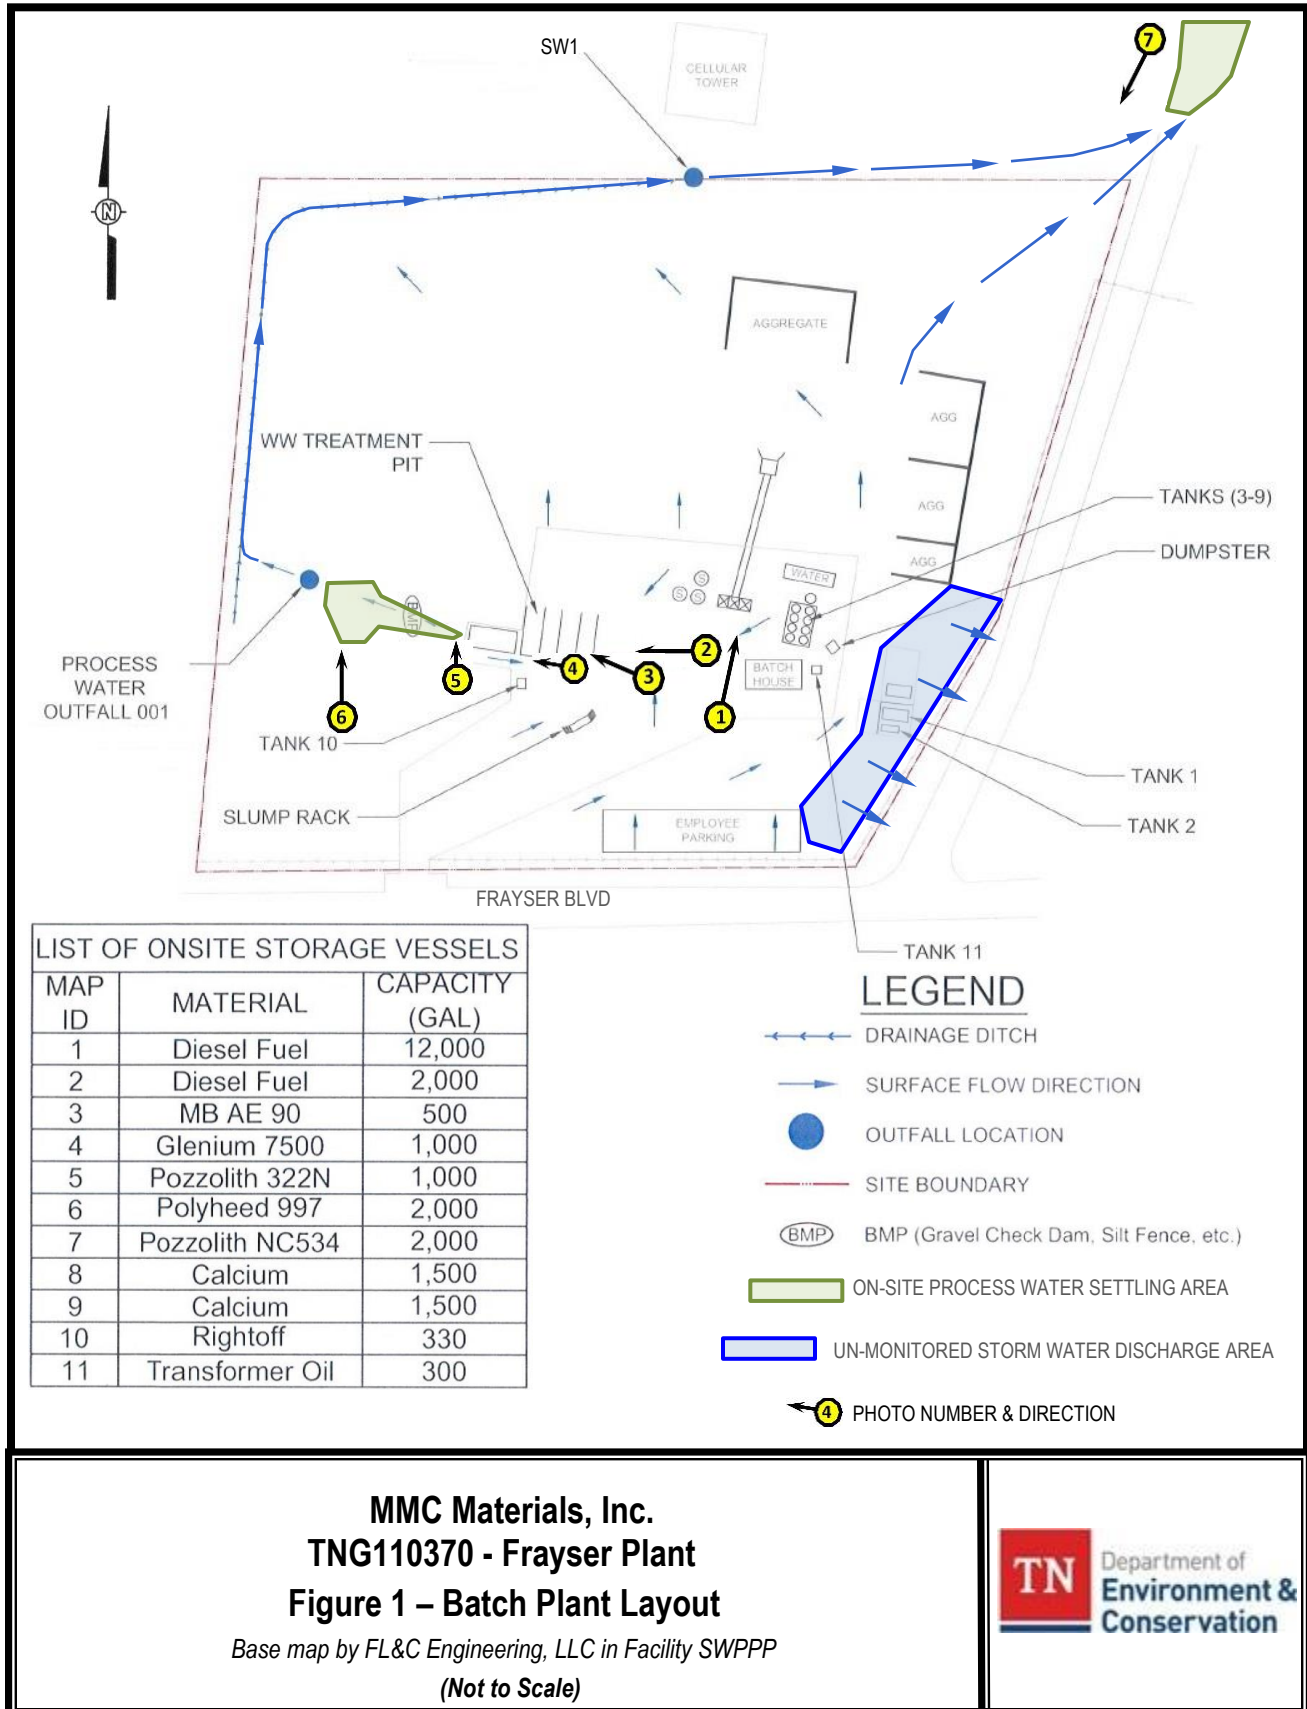
**MMC Materials, Inc.
TNG110370 - Frayser Plant
Figure 1 – Batch Plant Layout**

View north showing the on-site collection point for process water after it leaves the multi-basin treatment system. Though the area shown had a thin veneer of cementitious material and a minor amount of floating residue (green arrows), the water itself was mostly clear at the time of the inspection. The blue arrow shows the flow direction from the treatment basins to the low area west of the basins. The yellow arrow shows the location of Outfall 001 to the perimeter drainage ditch (see Figures 1 and 2).

View south showing the eastern low area that receives 1) process water flow (blue arrow) from the aggregate stockpile watering (red arrow) on the east side of the batch plant, and 2) potential process water flow (teal arrow) from the treatment basins via the diversion ditch along the north side of the batch plant (Fig. 1). The water - mostly clear at the time of the inspection - collects and infiltrates at this location (see Fig. 1). Flow from this area would exit the site to the left (east) of the area shown.
